MEA degradation in PEM Fuel Cell: a joint SEM and TEM study

R.A. Silva¹, T. Hashimoto², G.E. Thompson² and C.M. Rangel¹

¹LNEG, Fuel Cells and Hydrogen Unit, Paço do Lumiar, 22 1649-038 Lisboa, Portugal
email: raquel.silva@lneg.pt; carmen.rangel@lneg.pt

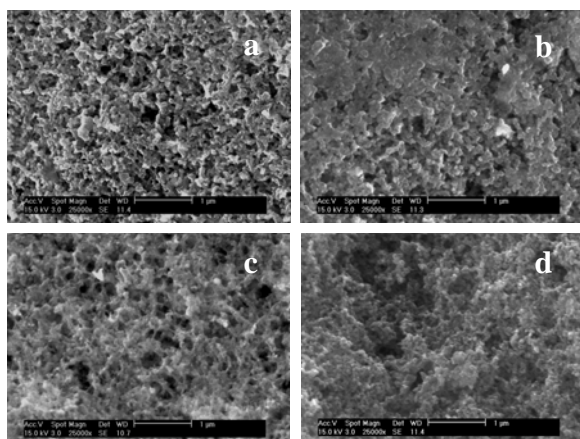
Typical results can be observed in Figure 2 for the anodic layer for cells 2, 4 and 7 which appear markedly different from the unused sample. Images were taken at 25000 X magnification.

Surface area seems to be lost with cycling. After use and for all the cells, the catalytic layers present a more compact and less porous structure when compared with the unused layers. Part of the problem is probably resulting from the clamping forces to which the cells of the stack are subjected in the sealing and assembly process. Compressing the cathode might have contributed to alter the original morphology. This was more evident for cell 8 for which it was not possible to peel away the carbon paper.

Fig. 2 SEM anode surface morphology for cells 2 (a); 4 (b), 7 (c) and unused sample (d).

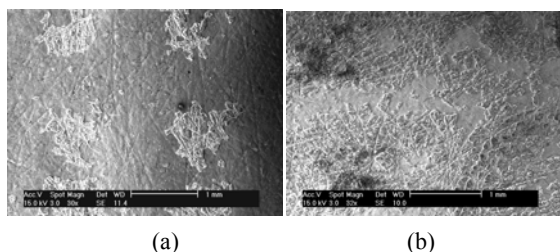
Figure 3 shows the GDL debris for cell 2 and cell 7. In the last cell of the stack, it was not possible to remove the GDL at the anode and it was very difficult to remove it at the cathode, leaving carbon fibers from GDL attached to the catalytic surface.

This observation corroborates the idea that a high assembly pressure was used in the assembly of the stack and caused the bipolar plate to press the GDL into the catalyst layer. Whilst not the purpose of this study, it is considered important to find, in the future, an optimal torque for this stack design and for the materials used on its construction, establishing a compromise between the tightness of the stack, the contact resistance and the deformation of the different materials.

Fig. 3 GDL debris at anodic layers of cell 2 (a) and Cell 7 (b), after 1500 h of operation.

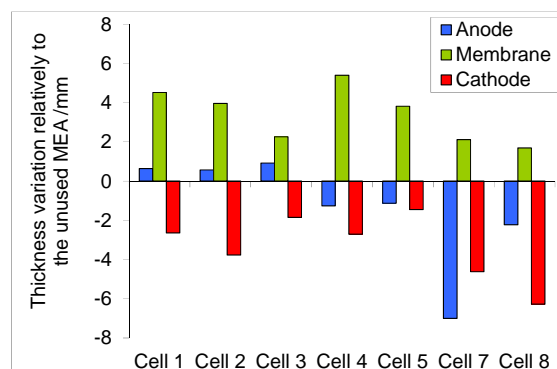
Figure 4 shows for three MEA components (membrane, anodic and cathodic CLs) their thickness variation comparatively to the unused MEA. The cathode thinning occurs in all the cells being more evident for the cell that suffered the highest degree of degradation and for which the assembling pressure have more drastic consequences (Cell 8). The thickness variations have an effect on the resistance through the MEAs. The thinner areas of the catalyst layer will have a lower electronic resistance, while the thinner electrolyte areas lower ionic resistance.

Fig. 4 Thickness variation of MEA components for some of the stack cells, relatively to the unused MEA.

The cathode of all cells showed a thinning which is more pronounced as the cells were farther to the hydrogen inlet in the stack. Cell 8 showed a thinning of about 47% after all the tests. At the anodic layer the thinning is significant only for cells 7 and 8. The anode thickness thinning was lower than observed at the cathode, corresponding to a decrease of about 21% for cell 8.

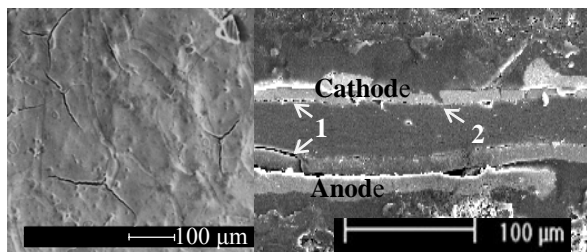
A very common feature among all of the analyzed CLs is the cracking. Figure 5 (a) shows a SEM image of a cracked CL. The integrity of the CL is compromised by cracks, but leaves the NafionTM membrane mechanically undamaged (fig. 5b). Thus, the fuel cell can still operate, but performance and durability may be reduced. On the other hand, the cracks will provide areas where the water could accumulate preventing reactant gases to reach the catalytic sites and consequently, reduces the reaction rate. Another important consequence is the catalyst erosion due to the exposure of the catalyst surfaces to agents such a water and gas flux.

In addition to cracks through the electrode thickness, delaminations between the electrode and the membrane are real failure modes (fig. 5b). Even small delaminations may affect the integrity and mechanical response of the MEA. Evidence of delamination was seen in both fresh and aged samples, which may put the question of the influence of the method of preparation. However, it was more predominant in aged samples. This type of defect may result from MEA manufacturing procedure but can also be induced by the degradation of the catalytic layer. It forces the current to flow away from delaminated zones, through neighboring regions in which heat is locally produced. As these neighboring zones are

also prone to water accumulation, they may degrade faster than other parts of the catalytic layers.

Fig. 5 Scanning electron micrograph of a catalyst layer with cracks (anode cell 7) (a). Cross section SEM view of the MEA for cell 7 showing delamination (1) and cracking (2) (b).

The compression force and the uniformity of the compression force between the land and under the channel are further important factors to mitigate interfacial damage. The compression force distribution under the channel is dependent of diffusion media material properties, the land width, and assembly pressure. However, the compression force under the channel is significantly lower than that under the land and, consequently, the possible maximum size of interfacial delamination is likely to be the channel width.

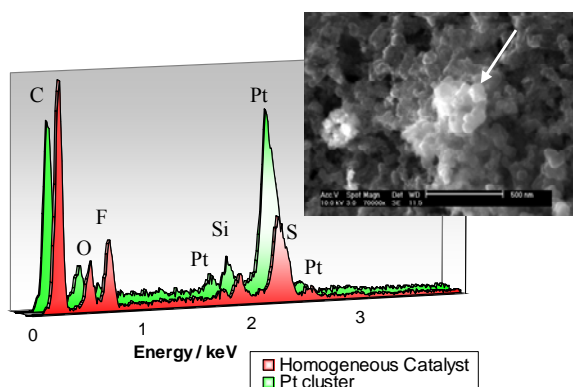
Another type of catalyst layer degradation found was the presence of platinum clusters, which is evident in Figure 6. EDS analysis was performed on clustered areas, which were shown to be platinum rich. A spectrum of a surrounding area, where clusters were not observed, is included for comparison.

Fig. 6 Pt cluster on anodic layer C2, SEM and associated EDS on cluster and surrounding area.

The high platinum concentration could result from catalyst detaching from the carbon supporting surface. The catalyst agglomeration leads to a

gradual decrease in the electrochemically active surface area, increasing in this way the activation loss. The presence Si has also been identified. The use of silicone piping and the sealing gasket are believed to have introduced Si contamination in the MEA.

From the EDS results it is suggested that a severe degradation occurred on the PTFE ionomer used as a binder in the catalytic layer, due the fluoride content loss.

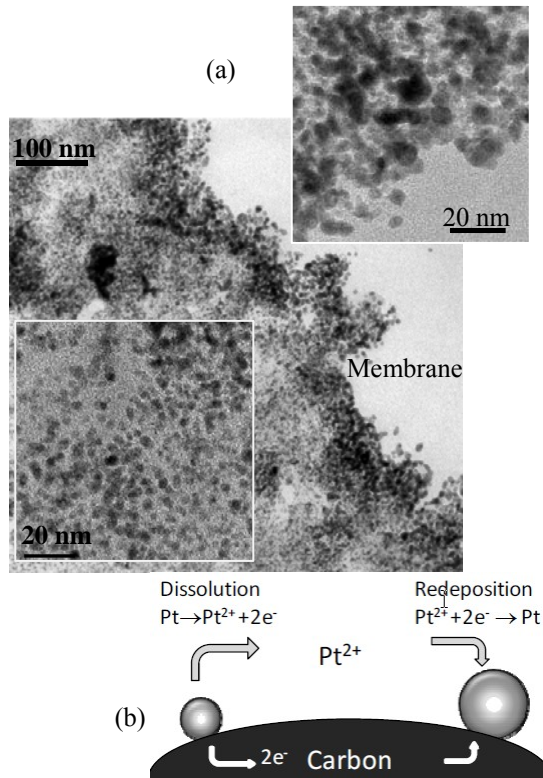
For cell 2, migration of platinum particles is evident in Figure 7a). The Pt-enriched zone was higher at the cathode CL/Nafion interface, with an enrichment depth of about 100 nm. According with the EDS results for the anode and cathode areas, there is an increment in Pt content (wt%) for the interfaces (anode/membrane and cathode /membrane) of 55.5% and 84.3%, respectively.

Probably this occurred by the Ostwald ripening mechanism, which involves platinum dissolution at the cathode, diffusion of the soluble platinum species from small to large particles into the interface cathode/membrane, followed by redeposition of soluble Pt into large particles (fig.7b).

A random selection of 35 spherically shaped platinum particles in the TEM images, revealed a more frequent Pt particle diameter of 3.75 nm for all the selected areas at the anodic catalyst layer. For the cathodic layer, the Pt particle diameter more frequent increases from 2.94 nm to 3.53 nm, as the examined area extends towards the membrane. Apparently, the platinum particle shape was unchanged, suggesting that a few Pt particles dissolved and migrate to the interface where they agglomerate due to the thermodynamically instability of the nanoparticles.

Fig. 7 TEM micrographs of cell 2 obtained from cathode (a) locations near the membrane interface. The mechanism probably responsible for the catalyst surface area loss (b).

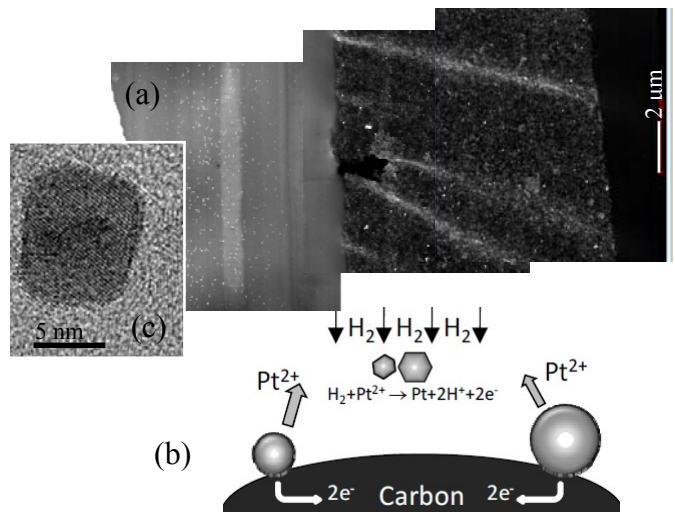
Another feature observed by TEM was a presence of platinum inside the membrane of cell 4, at 2 mm from the anode (fig. 8 a), which probably results from carbon corrosion at the cathode. The loss of Pt from the carbon support and the loss of electrode

activity are the main responsible for the performance decrease.

Hydrogen molecules can permeate through the proton-conducting membrane leading to a chemical reduction of any dissolved Pt that migrate through the membrane, resulting in deposition. (fig. 8b) The location of this Pt deposition in the membrane is dependent on the partial pressure of oxygen in the cathode. The higher the partial pressure of oxygen, the farther from the cathode the Pt deposition occurs. The deposited platinum particle changed from the original shape (spherical) now showing a rectangular shape (fig. 8c) which, from the literature, is an indicative of this mechanism [16,17].

Fig. 8 TEM micrographs of cell 4 obtained from the anodic side where a platinum band it is visible in the membrane (a). A high magnification image of one of these particles found inside the membrane (c). The possible mechanism that occurred (b).

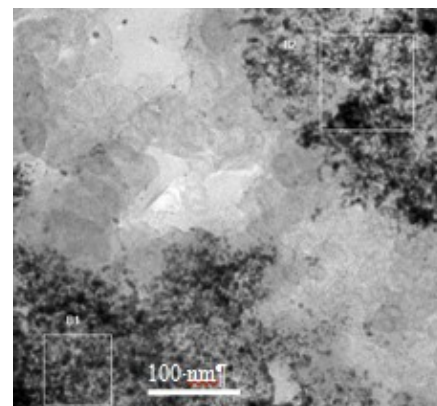
At anodic layer of cell 7, carbon particles are visible without any platinum particles, suggesting platinum dissolution and further migration and agglomeration inside the catalyst layer with larger sizes occurred (fig. 9). In this layer, void spaces and brighter areas are also observed indicating the possibility of carbon corrosion.

Fig. 9 TEM micrographs of cell 7 obtained from inner layer inside the anode.
