Stains in Pavement Applications of a Portuguese Limestone

The case study reported in this paper is related to the appearance of spots on a floor covered with a Portuguese ornamental limestone in a hotel in Portalegre (Portugal).

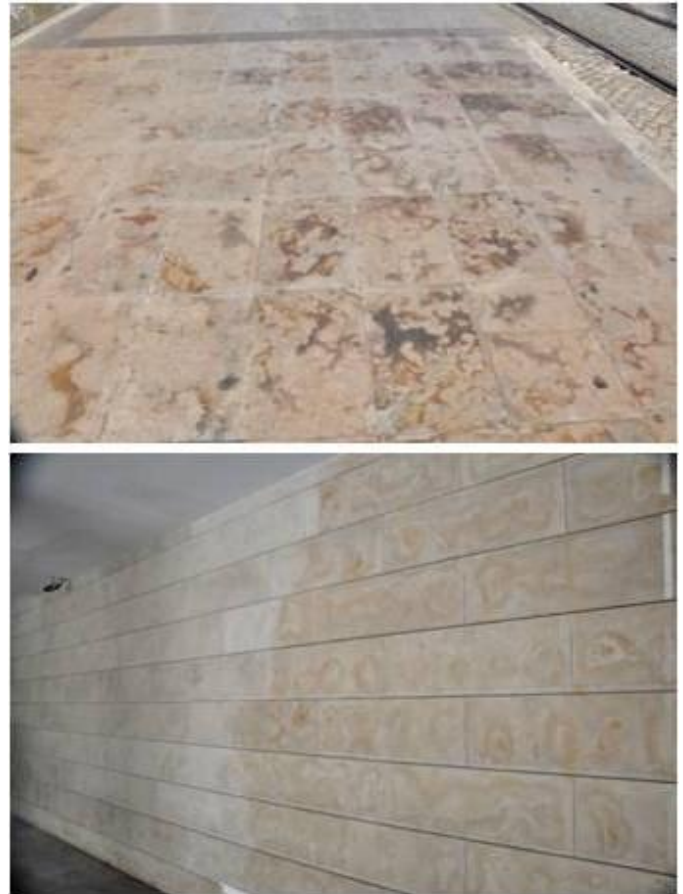
These stains had an orange to red-brown colour and appeared soon during the first year after the application of the stone slabs on the floor. The source of the stains is not known and they can be caused by the cement base or by the stone. Even after washing and completely removing the stains they reappeared.

This type of situation can be observed in different locations in applications in outdoor pavements as well as in interior cladding (Figure 1).

Figure 1 — Example of stains in limestones applied in pavements (up) and cladding (down).

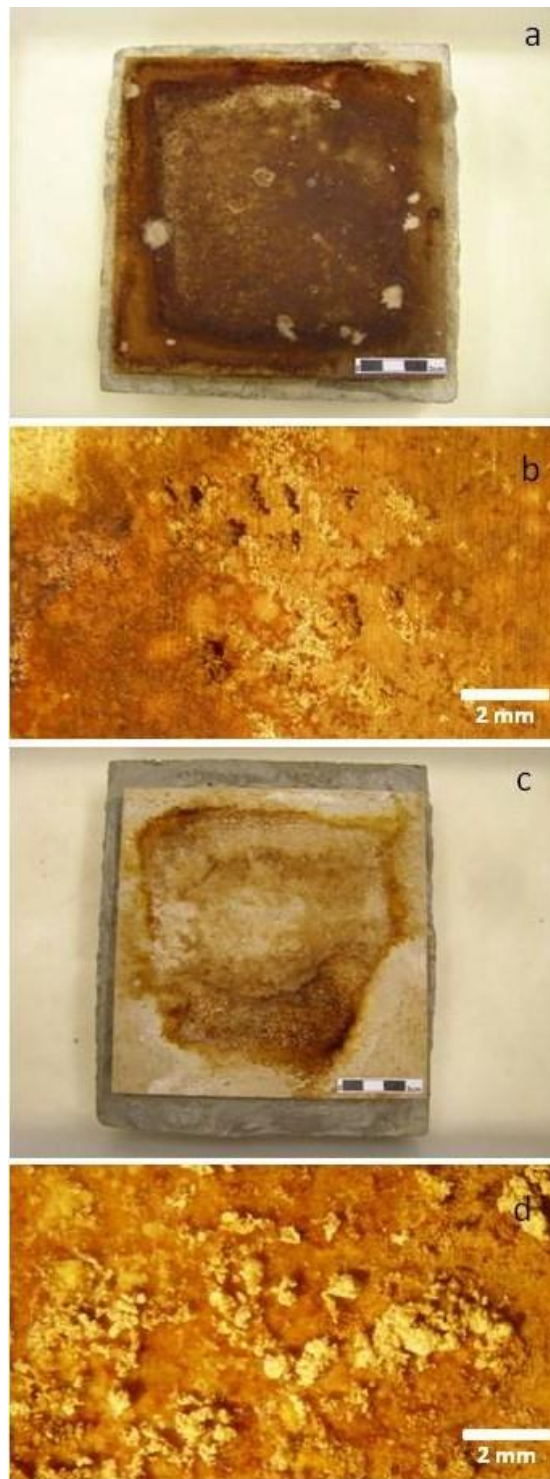
On the stone slabs bonded to the base mortar reddish brown stains appeared after 3 days of the beginning of the test.

These stains gradually grew getting stronger and more intense reddish brown colour, and after two months showed the very negative aspect that can be seen in Figure 8a.

Efflorescences corresponding to alteration minerals were formed and were photographed (Figure 8b) and collected for analysis.

In the stone slabs which were in direct contact with epoxy mortar but with base mortar at the bottom, the effect was similar to the described above but in this case the

stains were more light-coloured, brownish orange, and its appearance was slower and less intense showing the inaeesthetic aspect shown in Figure 8c .

Efflorescence also formed in this limestone slab (Figure 8d) which was collected for analysis.

Figure 8 - Reddish brown stains in stone slabs bonded with base mortar (a) and efflorescences (b). Reddish brown stains in stone slabs glued with epoxy mortar but with base mortar at the bottom (c) and efflorescences (d).

It was concluded that the base mortar is at the origin of the stains. The substances in the constitution of the base mortar were dissolved by water and migrated by capillary to the surface of the stone.

This stone slab was also washed and in this case all stains and efflorescence were removed. The test was also repeated for another two months and only a few light-coloured stains appeared.

Whenever there was a layer of epoxy mortar between the stone and the base mortar, the effects were attenuated resulting in lighter and smaller stains that can be washed. The epoxy mortar had an isolating effect but not completely efficient.

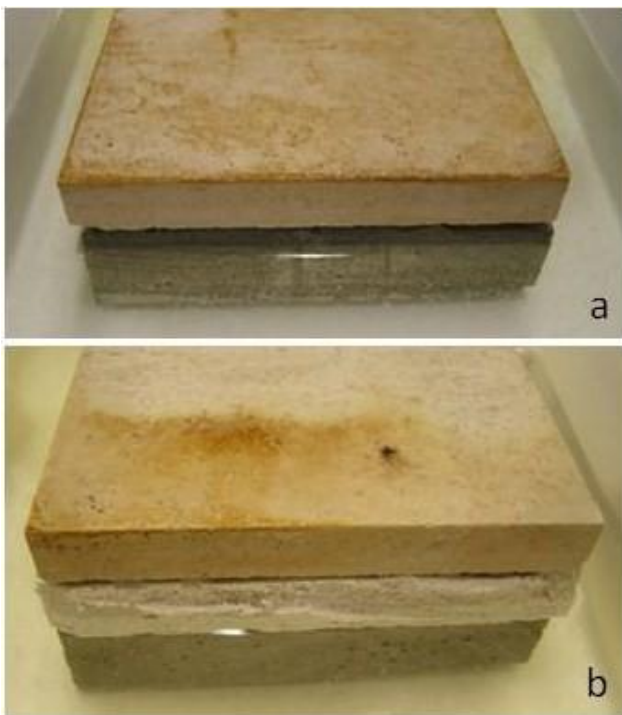
In the slabs of the three materials only in contact with each other but not glued together (Figures 9a and 9b) the appearance of light-coloured stains similar to those of the bonded samples was recorded.

Figure 9 - Reddish brown light-coloured stains in stone slabs in contact with the base mortar (a) and in contact with the epoxy mortar above the base mortar (b).

The contact between the stone slab and the fixing materials was done only at some points but it was still enough for the material that constitutes the spots migrate by capillarity to the surface and edge of the samples.

Thus, it was found that the sources of the stains would be in the base mortar.

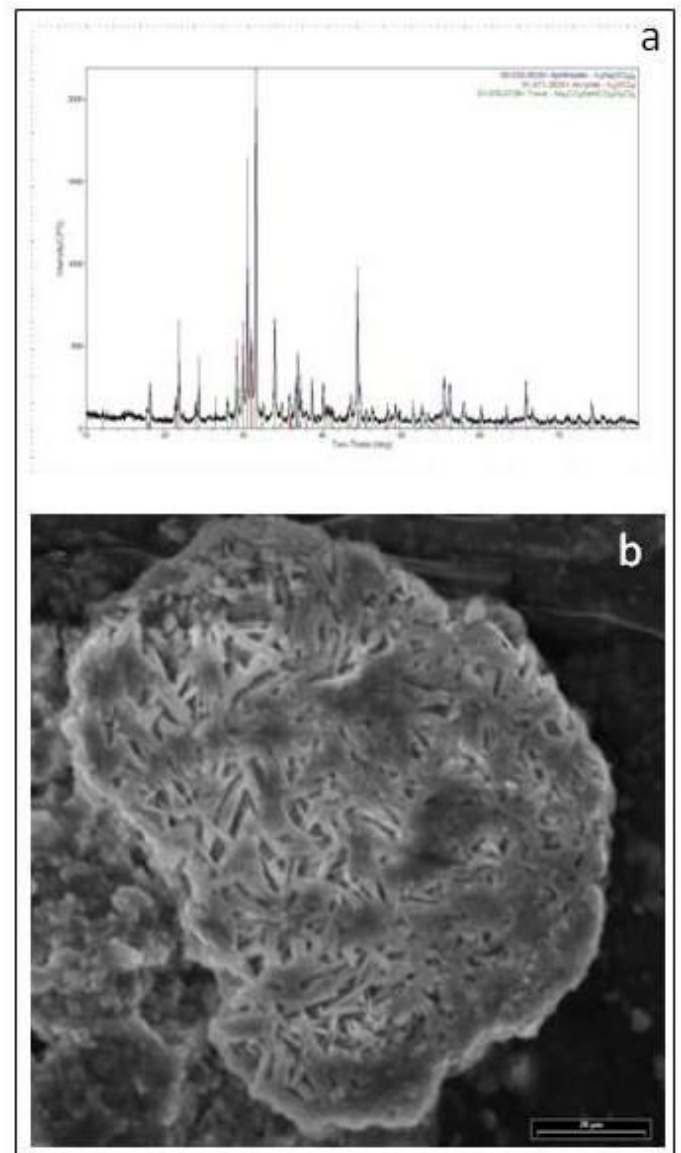
Figure 10 – a) X-ray diffractogram of the efflorescence and b) SEM microphotograph of an aggregate of these materials.

The x-ray diffractogram shown in figure 10a identifies the crystalline phases of the efflorescence where Na and K sulphates and Na hydrate carbonates were found. This identification was confirmed by the SEM analysis and a microphotograph of an aggregate of these materials can be observed in figure 10b.

This migration was intense and, besides the reddish brown stains, probably due also to iron oxides (to be confirmed), resulted in the formation of efflorescences of hydrated sulphate and carbonate minerals.
