Intumescent Gels for Fire-Resistant Glass: Thermal Insulation, UV Protection, and Durability Studies

M. A. Esteves, A. Capelo, M.T. Donato, F.A. Costa Oliveira, C. Ferreira, I. N. Alves, J. Correia, R.M.L. Silva H. Hashim, D. Roy, J.P. Teixeira, J. Rocha, P.M.P Salomé, T.C. Diamantino, M.A. Barreiros

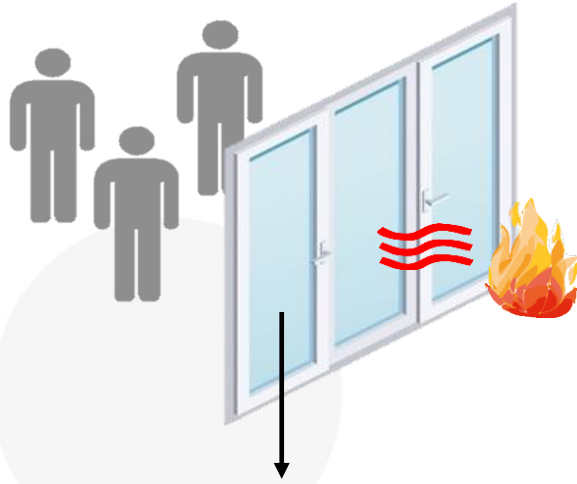
Fire tests

EI30 Fire-rated glass according to EN 13501-2 standard:

Integrity and insulation for 30 min.

- Flames and flammable gases don't pass.
- Temperature increase above ambient of opposite side of glass: Maximum ≤ 180 °C for each individual measurements, average temperature measurements ≤ 140 °C).

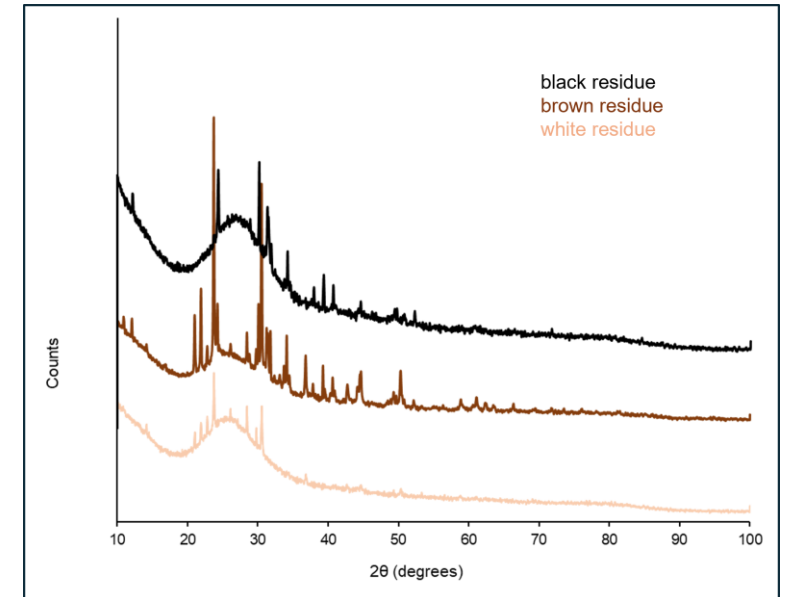
F9

XRD peaks correspond to metastable phases, which are different for each residue.

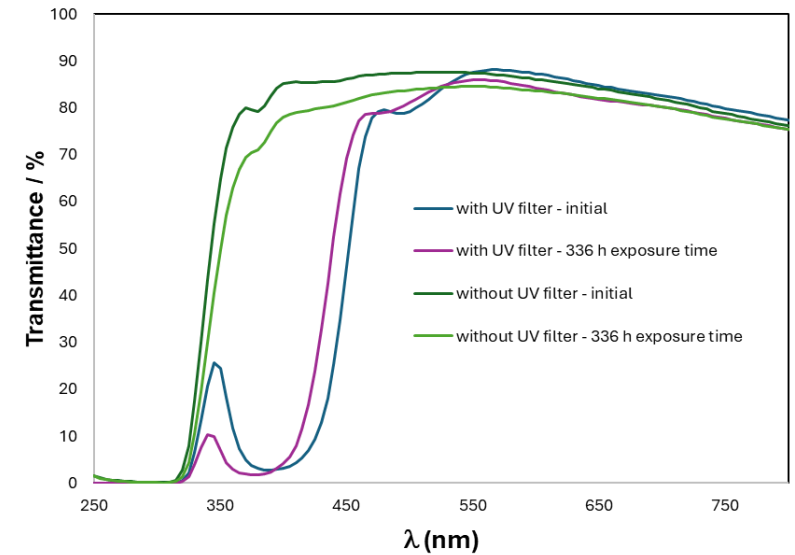
UV-Vis

Durability tests according to ISO 12543-4:2021

Radiation test- exposure to Xenon arc source (336 h)

- Multilayer Bragg Reflector (MBR) coating to the outermost surface proved effective for UV protection.

- ❖ Preliminary durability tests of the glass assemblies indicated improved UV protection, attributed to the application of a MBR coating on the outermost surface.
