Stains in Pavement Applications of a Portuguese Limestone

The case study reported in this paper is related to the appearance of spots on a floor covered with a Portuguese ornamental limestone in a hotel in Portalegre (Portugal).

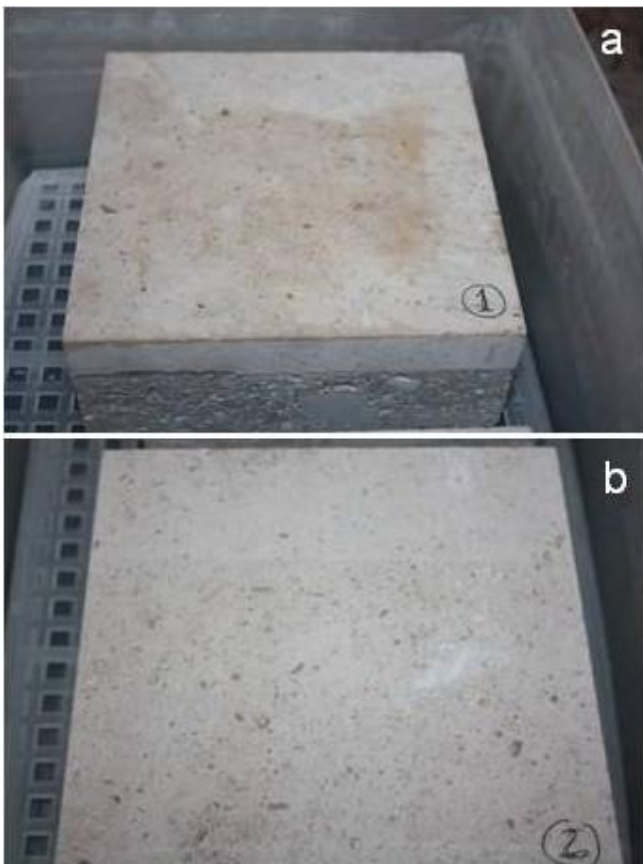
Figure 5 - Container with a stone slab bonded to base mortar with cement diluted in water (a) and container with a 3 layer arrangement: base mortar at the bottom, epoxy mortar in the middle and stone slab at the top, all bonded together (b).

On the stone slabs bonded to the base mortar reddish brown stains appeared after 3 days of the beginning of the test.

These stains gradually grew getting stronger and more intense reddish brown colour, and after two months showed the very negative aspect that can be seen in Figure 8a.

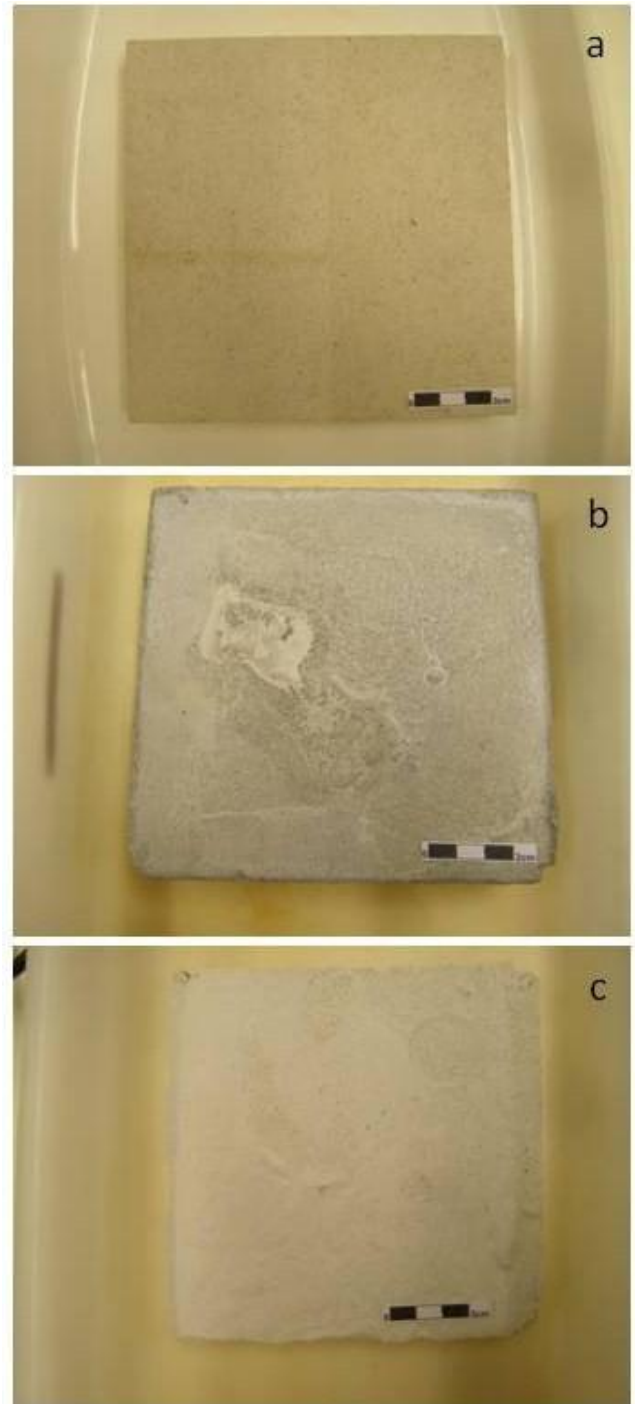
Figure 6 - Containers with slabs of the individual materials: stone (a), base mortar (b), epoxy mortar (c).

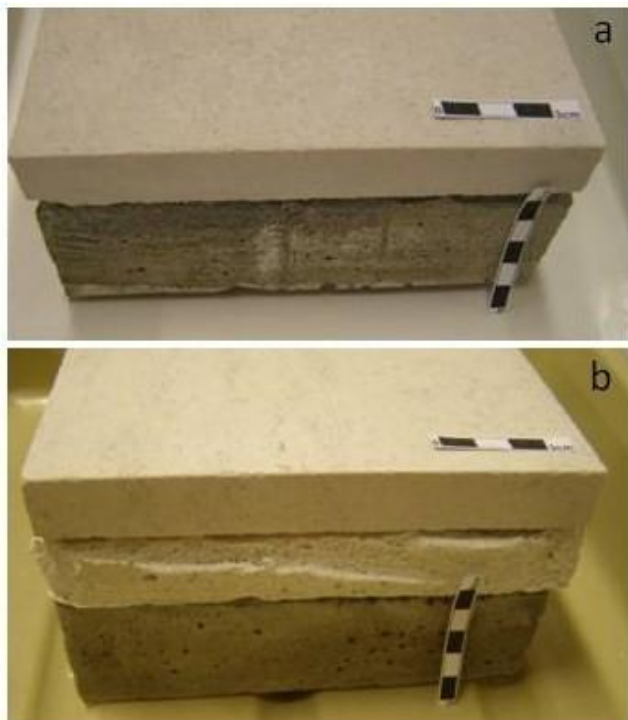
Figure 7 - Containers with slabs of the different materials just on top of each other (without gluing them): plain mortar+stone (a); plain mortar+epoxy mortar+stone (b).

In the slabs of the three materials only in contact with each other but not glued together (Figures 9a and 9b) the appearance of light-coloured stains similar to those of the bonded samples was recorded.

Figure 9 - Reddish brown light-coloured stains in stone slabs in contact with the base mortar (a) and in contact with the epoxy mortar above the base mortar (b).
