INTRODUCTION

This work, which is part of a National Joint Industry Project (PROTEJO) on corrosion protection for ships built entirely in aluminium - catamarans, presents the results of 2 years of the 3 years of natural exposure test performed in estuarine environment. The aim of this long-term exposure test was the characterization of the corrosion behavior of the alloy AA5083 in splash and immersion zones, and also the assessment of the microbiological influence on the corrosion process.

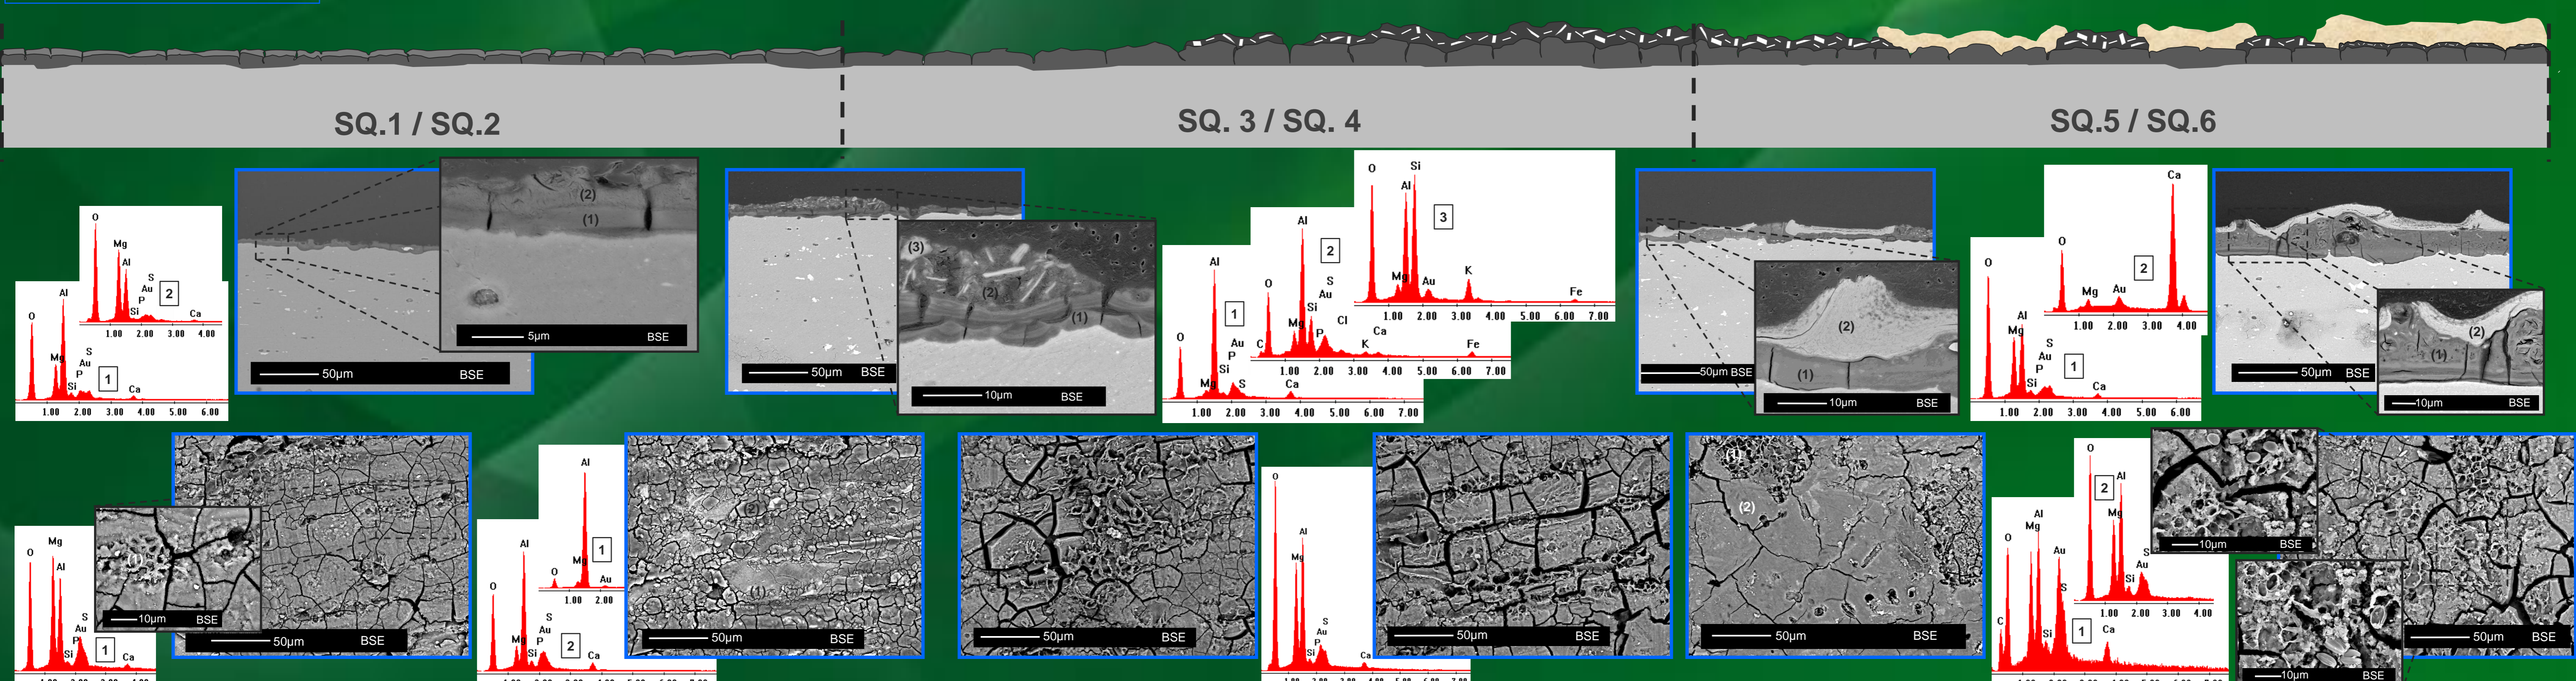
IMMERSED ZONE

Profile representation of AA5083 surface after 2 years of Estuarine exposure

- The presence of calcareous deposit on the alloy surface exposed in the immersed zones indicates a biomineralization process (SQ5/SQ6). The formation of pitting has not been observed on the surface totally covered by a biofouling layer consisting mainly by adherent brown and red algae.
